NACE SP0590-2015  
Item No. 21046

# Prevention, Detection, and Correction of Deaerator Cracking

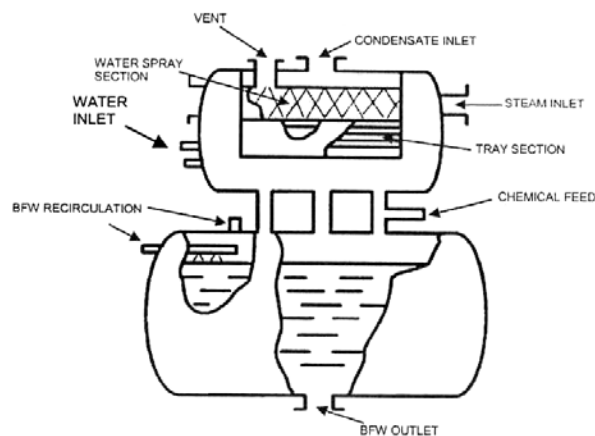
Figure 1(a): Typical Mechanical Feedwater Deaerator

1.2.1 The function of the deaerator in the steam plant cycle is to reduce oxygen and other dissolved gases in the feedwater to acceptable levels. Usually, oxygen content can be reduced to less than 10 µg/L (ppb) as shown in Table A1 (see Appendix A [nonmandatory]). Two typical designs of mechanical feedwater deaerators are shown in Figures 1a and 1c. Figures 1b and 1d show the weld areas associated with each type of unit. The steam used in these systems raises feedwater temperature, which lowers the solubility of oxygen. With proper venting, the steam also serves as the stripping gas, removing the oxygen from the system. In these systems, the deaerator provides feedwater storage and proper mechanical conditions for the feedwater pump.
