**AS1895™/21**

CUSTODIAN: G-3/G-3A		PROCUREMENT SPECIFICATION: AS1895	
	<b>AEROSPACE STANDARD</b>		<b>AS1895™/21</b>
	INSTALLATION, JOINT, V-RETAINER COUPLING ASSEMBLY

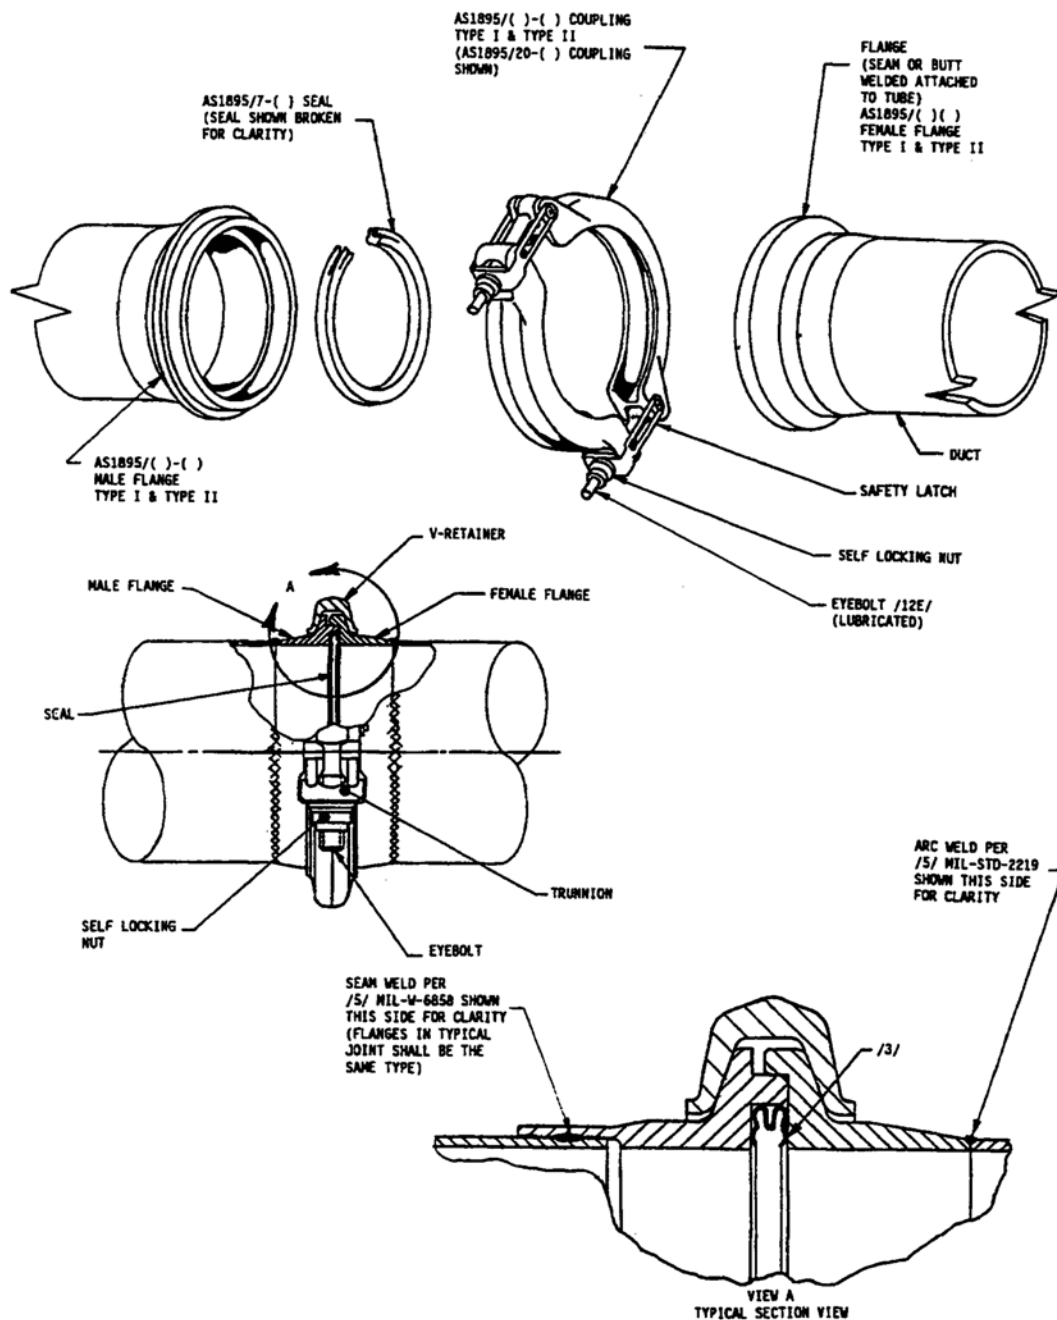
FIGURE 1 - AS1895 COUPLING FLANGES AND SEAL

- /5/ CRITICAL: FLANGE FLATNESS AFTER WELDING PER AS1895
- 6. CHECK COUPLING PART NUMBER TO BE SURE CORRECT COUPLING IS BEING USED.
- /7/ REMOVE PROTECTIVE CAP FROM FLANGE, INSTALL SEAL IN MALE FLANGE, AND BRING MATING FLANGE INTO POSITION. DO NOT INSTALL COUPLING OVER FLANGES, WHICH EXCEED THE ANGULAR MISALIGNMENT SHOWN IN FIGURE 4. IF FLANGES ARE MISALIGNED, DO NOT USE COUPLING TO ALIGN. CHECK SYSTEM AND FIND CAUSE. LOOSEN SUPPORT CLAMPS AS NECESSARY. UNHOOK LATCH ASSEMBLY FROM LUGS AND SLIP COUPLING OVER THE TUBING OR DUCTING ADJACENT TO THE FLANGE. MISALIGNMENT SHOWN IS INITIAL. FLANGE GAP MUST BE CLOSED WHEN INSTALLATION IS COMPLETE.

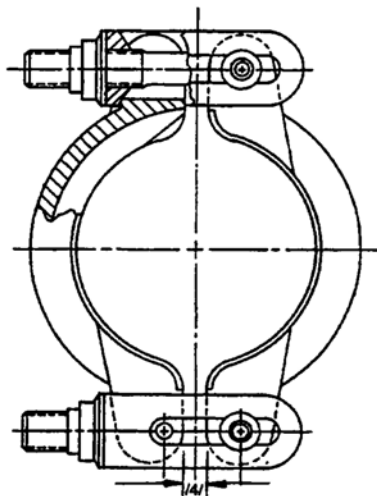
FIGURE 2 - CORRECT INSTALLATION DOUBLE LATCH COUPLING

- 12/ CHECK FOR FAULTY COUPLING OR WRONG PART AS FOLLOWS:
  - (a) BINDING OF BOLT AND LUGS
  - (b) INSTALLATION LOAD LOSS, IN EXCESS OF 20% AFTER 24 h
  - (c) CLOSURE OF LATCH GAP LESS THAN NOTED IN FIGURE 2 OR BUTTING OF LUGS AS NOTED IN FIGURE 3, BEFORE REQUIRED TORQUE IS REACHED

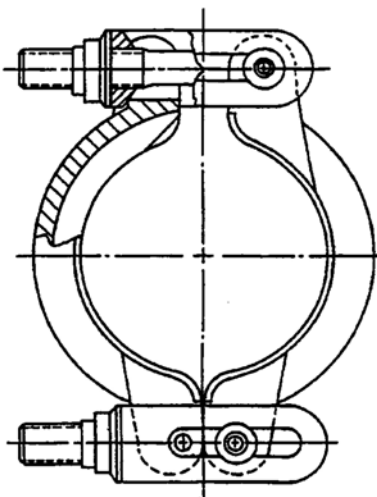
FIGURE 3 - INCORRECT INSTALLATION DOUBLE LATCH COUPLING /12c/

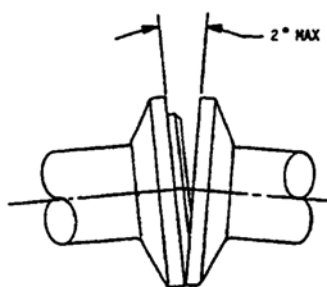
FIGURE 4 - INITIAL ANGULAR MISALIGNMENT /7/

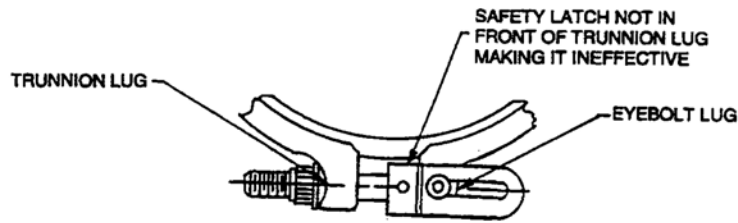
FIGURE 5 - INCORRECT INSTALLATION OF SAFETY LATCH /12/ SINGLE AND DOUBLE LATCH COUPLING

- (d) CRACK OR CRAZING IN V-RETAINER AND SAFETY LATCH
  - (e) UNLUBRICATED BOLT
  - (f) CHECK FOR PROPER ASSEMBLY OF SAFETY LATCH
  - (g) CHECK FLANGE FACE FOR FLATNESS (PER AS1895), SCRATCHES, AND DENTS
